INDUSTRIAL CASE STUDY

SEAMLESS FLAT ROOFING MEMBRANE

Project Overview: Waterproof Roofing Membrane

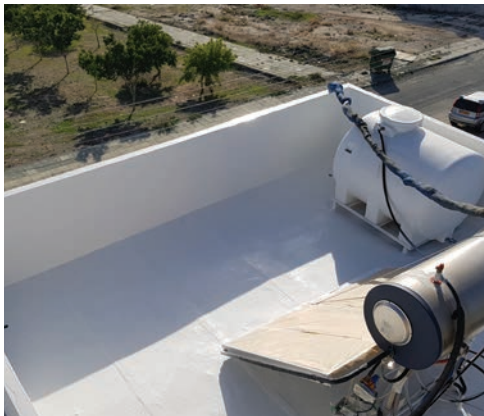
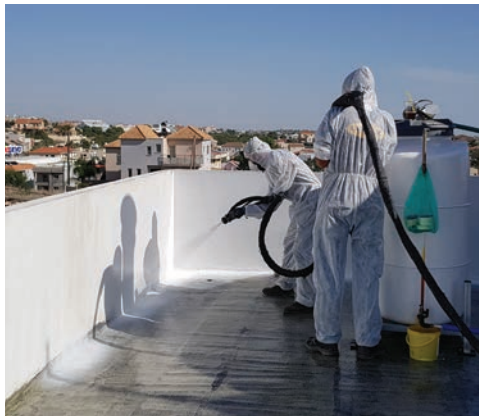
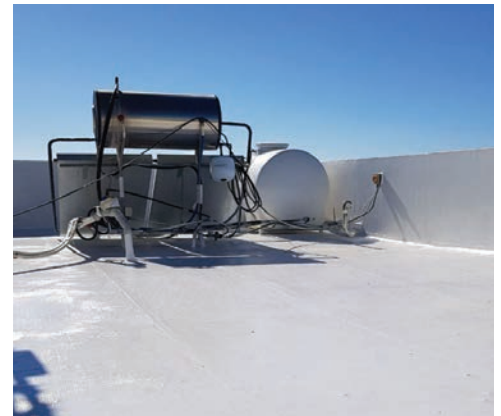
The roof was previously covered with bitumen, a type of asphalt commonly used for flat roofs. Bitumen can breakdown prematurely in fluctuating climate and weather conditions. In the heat of the summer months, the bitumen had cracked along the joints allowing the rainwater to seep through the existing membrane. Moreover, bitumen tends to absorb rather than reflect heat which can superheat the building below.

The previous bitumen was removed, and the area was completely cleaned and prepared prior to priming with Master-top P617 and quartz sand.

White XS-101 was then applied to completely seal the roof. A white top-coat was applied after the XS-101 to ensure UV stability.
