LIGHT INDUSTRIAL CASE STUDY

OIL PANS

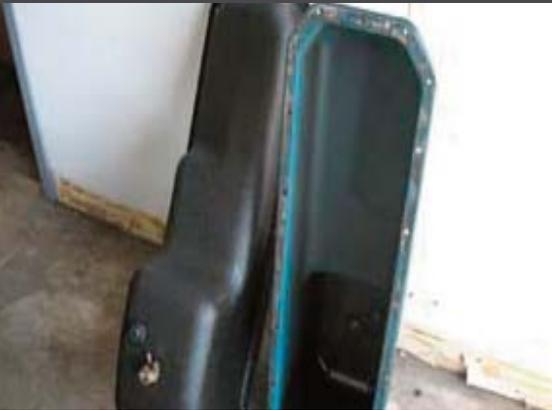
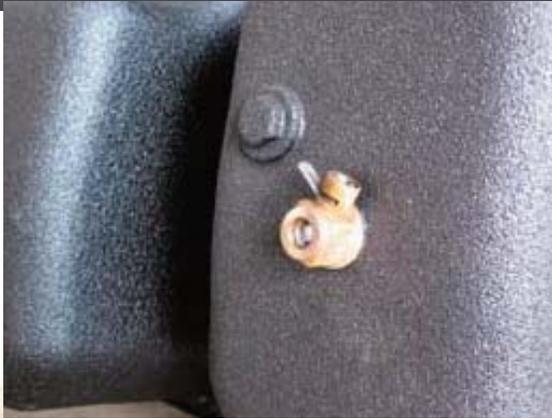
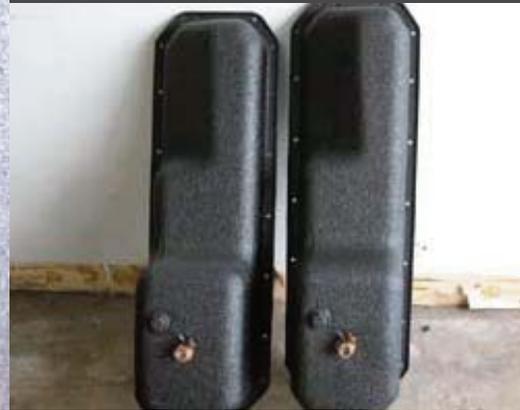
School buses, county and state service vehicles and public utility vehicles all have oil pans that are susceptible to serious damage during routine driving condition. Rocks and road debris often ding or dent the pans. They can also scratch the thin paint exposing the bare steel underneath to corrosion, rust and eventually leakage. The road debris can even puncture the oil tank, especially after repeated impacts. The risk is compounded when the vehicle travels on gravel or dirt roads or on rural routes.

The oil pans were removed from the vehicle and taken to the local LINE-X store. There they were thoroughly cleaned to remove any oil and contaminants prior to the aggregate blasting. This ensured that contaminants were not ground into the steel during the etching process. After blasting, the pans were sprayed with SF-515 to promote adhesion and ensure that rust would not spread if the LINE-X was never compromised. LINE-X XS-100 was then sprayed at a minimum of 60 mils for impact resistance, preferably 70-90 mils. Pans were completed in 1-2 days.

Note: care must be taken to avoid spraying the mating surface of the oil pan to the engine block to ensure proper reinstallation. Additionally, the oil drain petcock is left uncoated.

LINE-X XS-100 was applied in standard black on the outside of the pans to provide sustainable impact resistance. The application was completed with limited interruption in daily activities.
