## INDUSTRIAL CASE STUDY

# CONCRETE FOUNTAIN

**Project Overview:** Waterproof Membrane for A Concrete Fountain

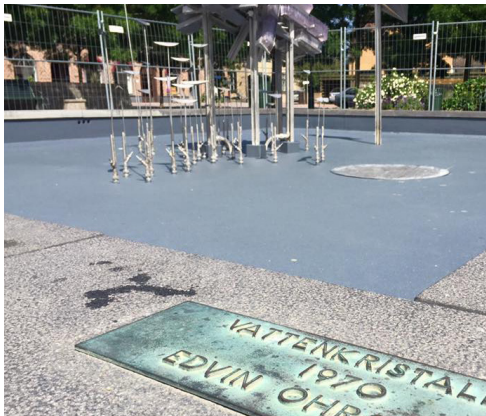
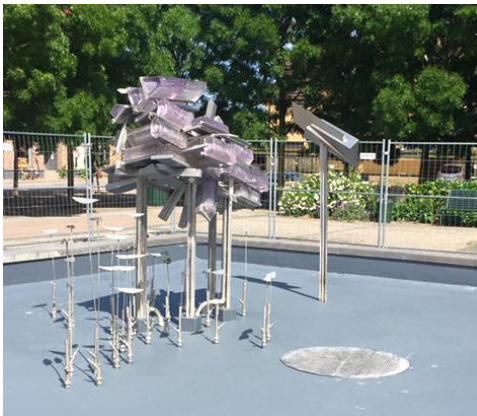
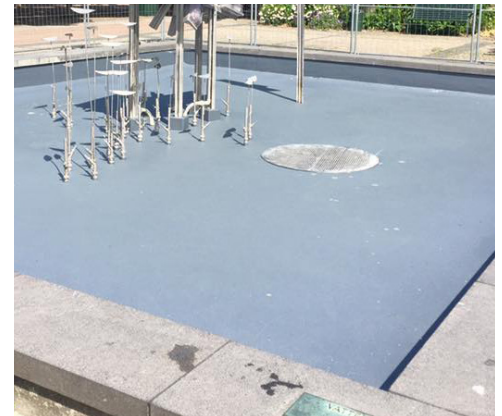
A popular public fountain designed by a Swedish sculptor and glass artist underwent a recent structural refurbishment. The fountain's six-by-seven-meter concrete floor needed a more durable waterproof barrier.

The fountain, built around 1970, has been susceptible to water ingress and weather corrosion. A new waterproofing solution was needed to ensure the work of art continues to stand for years to come.

A LINE-X spray-on polyurea coating was the ideal choice to repair and enhance the fountain's concrete floor. As a spray-on coating, LINE-X can be applied consistently, with no seams or gaps.

The existing concrete was cleaned and remedial works were carried out prior to the LINE-X application.

The surface was then ground and a LINE-X approved primer was applied to ensure good adhesion.

LINE-X applicators selected a pure polyurea coating, LINE-X XS-310, which is extremely resistant to moisture. The coating also has a longer gel time, 10-12 seconds, which allows it to achieve a smooth, attractive finish. LINE-X XS-310 was applied at 3mm thick to ensure a high level of durability and waterproof seal.
