Dialysis Clinic

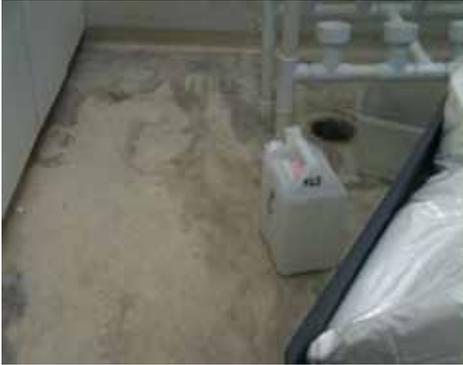
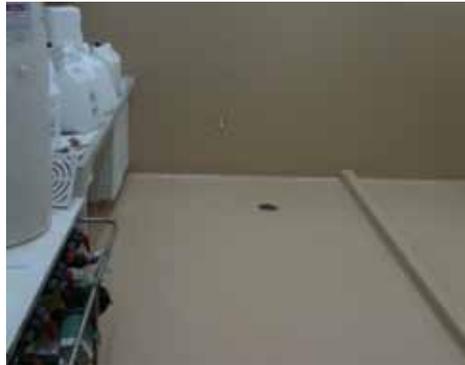
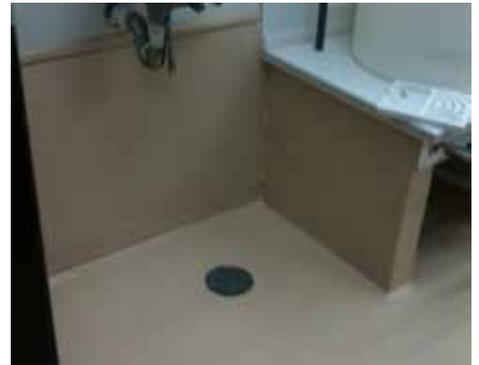
Dialysate is the main chemical used in dialysis and is very corrosive. Epoxy and vinyl floor coatings fail because any spilled or leaked dialysate penetrates the coating and attacks the underlying concrete floor.

When the failure is ignored, moisture leaks down to lower floors and walls leading to more damage.

LINE-X created a chemical and waterproof membrane on the floor and walls using LINE-X XS-310.

Before spraying, the LINE-X team repaired the damaged areas of the concrete floor. Then XS-310 was applied to the floor and 5 feet high along the wall at a thickness of 1/8th inch. This protected the area from chemical spills and water leakage while providing a tough surface that would withstand repeated use and maintenance.

A layer of ASPART-X was applied to allow for easy clean-up. This would ensure that the dialysis area maintained proper sanitation for patients.
