LIGHT INDUSTRIAL CASE STUDY

HITCH RECEIVER PLATES

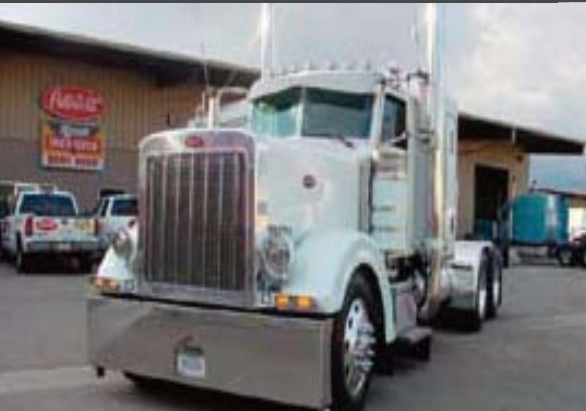
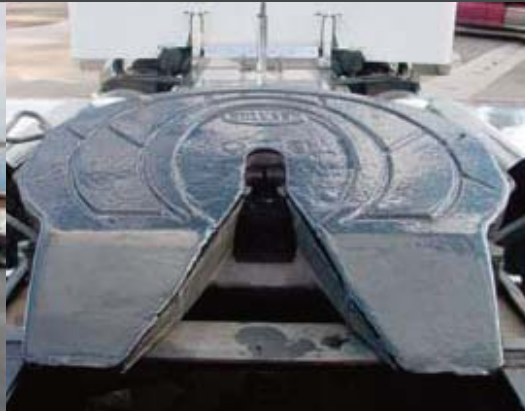
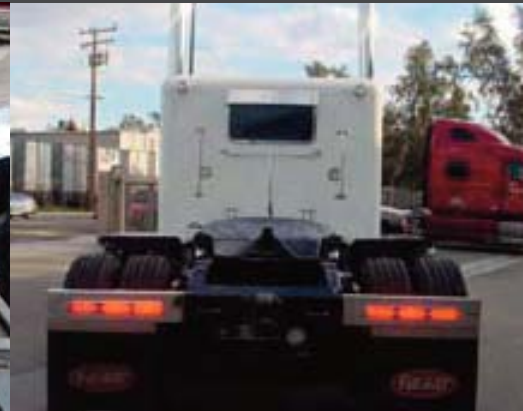
Hitch receiver plates typically require grease or a Teflon® disc to minimize friction between the receiver and trailer. The problem arises when a greased receiver hooks on to a trailer with a Teflon® disc. The greased receiver causes a breakdown of the Teflon® coated disc. Each time a trailer is switched, depending on what has been used, the receiver plate must be recoated. This process is messy, expensive and takes time.

The hitch assembly is removed from the vehicle. The hitch assembly is degreased and carefully masked to protect areas left uncoated, ie. the underneath mounting platform and inner section where pin is received. Once masked, the assembly is then sandblasted and primed. New units are simply masked, sandblasted and primed. Once these steps are completed, a 1/8" thick coating of LINE-X® XS-350 is applied. Unit is then unmasked. The cure time is approximately 48 hours and the unit is ready to go.

LINE-X XS-350, while offering exceptional corrosion and abrasion resistance, provides a smooth slippery surface eliminating the necessity of adding grease or slip disks to the assembly. This allows for quick and easy hook-ups every time. It also reduces the expense of grease or having to recoat Teflon.
