Petrol Island Refurbishment

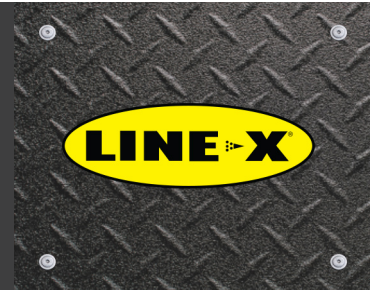
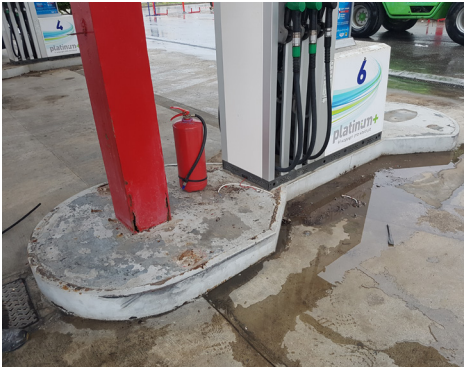
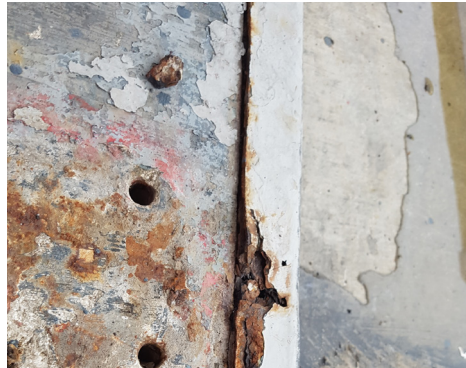
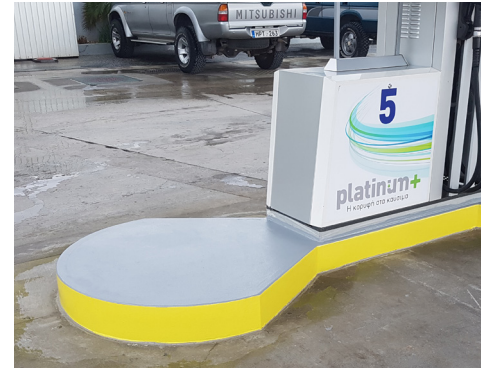
Petrol station pump islands made of steel bezel and concrete often fail due to continuous use. Diesel and gasoline spills rust and corrode the metal bezel, and car tires wear down the concrete islands over time. As a result, the company had to fix and paint the islands every six to twelve months. That was a problem for the company, because even between re-coating, the islands were looking worst for wear.

Pump islands were repaired and primed before the LINE-X application to ensure proper coating adhesion. Once LINE-X XS-350 was sprayed to the ideal thickness, a UV topcoat was added to prevent fading or discoloration. Start to finish the job took two working days to complete.
